Manhole Inspection Summary

Manhole # S13GG_040MH

Insp Date: **6/25/09 9:03 AM**

Location Address: **REAR OF 2816 BAKER ST**

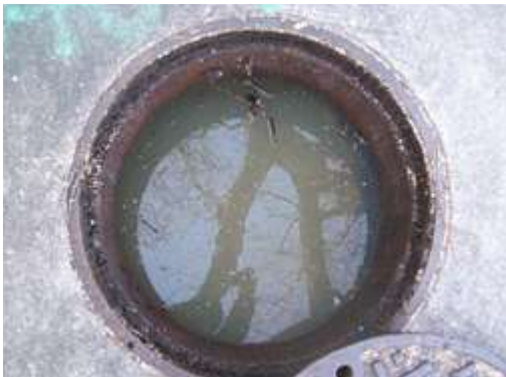
Defect 5

Surcharge ☒ **Evidence Of Surcharge** Depth: **2** (ft.) ☐ Active Surcharge Present

SURCHARGE

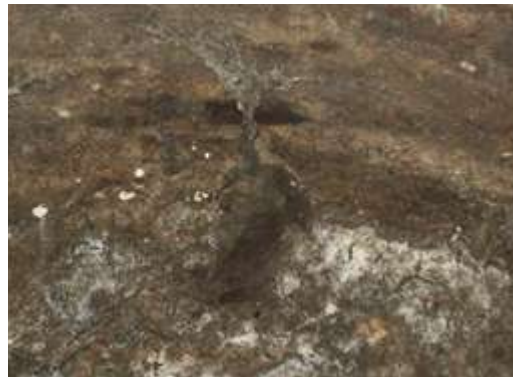
Defect 4

Condition: ☐ Sound ☐ Cracked ☒ **Root Intrusion** ☐ Loose Brick ☐ Deteriorated

Infiltration: ☐ None ☐ Joint ☐ Cracks ☐ Mortar ☒ **Roots** ☐ Wall

ROOT INTRUSION IN BARREL

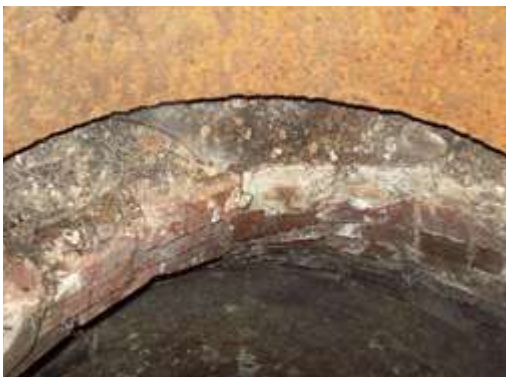
Defect 3

infiltration at roots

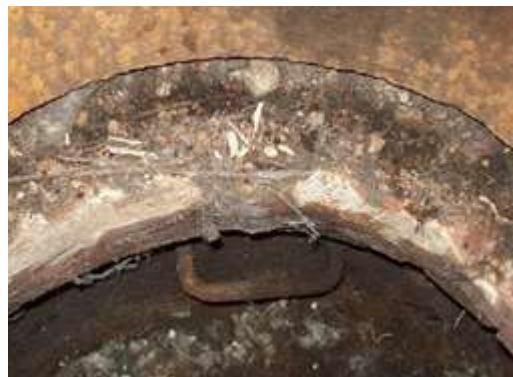
Defect 2

Condition: ☐ Sound ☐ Cracked ☒ **Root Intrusion** ☐ Loose Brick ☒ **Deteriorated**

Infiltration: ☐ None ☐ Joint ☐ Cracks ☐ Mortar ☒ **Roots** ☐ Wall

root intrusion at chimney, deteriorated

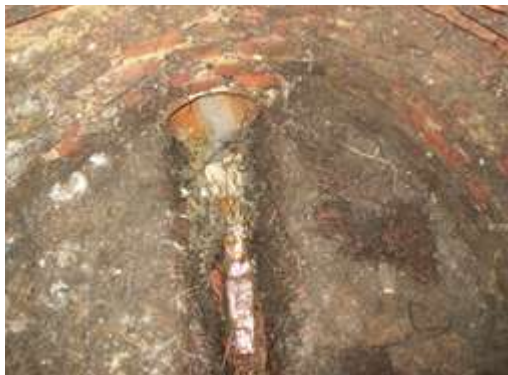
Defect 6

DEBRIS IN CHANNEL AND BENCH

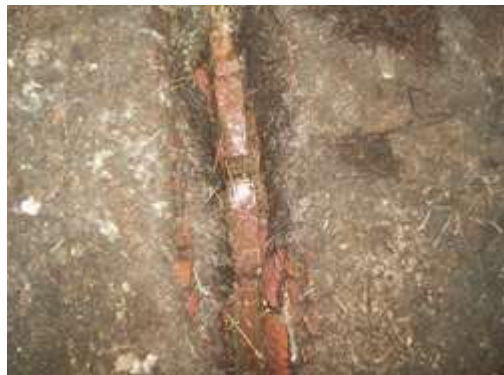
Defect 5

Condition: ☐ Sound ☐ Cracked ☐ Root Intrusion ☒ **Deteriorated** ☐ Leaks ☒ **Debris**

Condition: ☐ Sound ☒ **Cracked** ☐ Root Intrusion ☒ **Deteriorated** ☐ Leaks ☒ **Debris**

DETERIORATED BENCH AND
CHANNEL

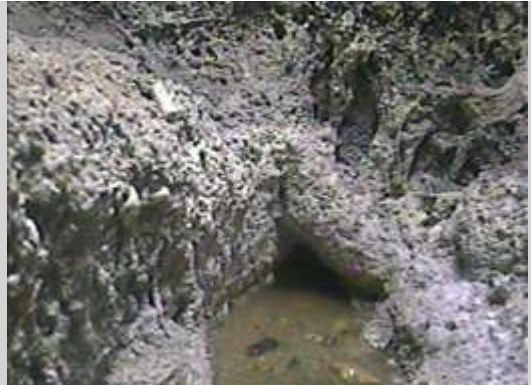
12 O'Clock Outflow

SURCHARGE

Pipe Height: (in.) Direct
Pipe Material: **Clay** ☐ Pipe Lined
Invert Depth: **4.95** (ft.) Flow Characteristics: **Slow**
Deposits: ☐ None ☐ Mud ☐ Sludge ☒ **Debris** ☐ Grease
Silt Depth: **8** (in.) Deposits Extent: **Heavy**
Infiltration: **Evidence** Pipe Seal Cond: **Unknown**

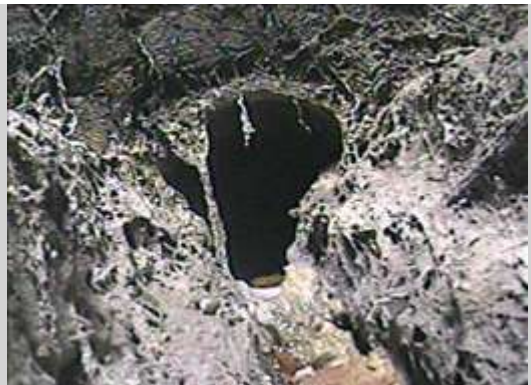
6 O'Clock Inflow

Pipe Height: (in.) Direct
Pipe Material: **Clay** ☐ Pipe Lined
Invert Depth: **4.80** (ft.) Flow Characteristics: **Slow**
Deposits: ☐ None ☐ Mud ☐ Sludge ☒ **Debris** ☐ Grease
Silt Depth: **3** (in.) Deposits Extent: **Medium**
Infiltration: **Evidence** Pipe Seal Cond: **Unknown**
